Manhole Inspection Summary

Manhole # S29K1_015MH

Location Address: **2200 Seamon Ave.**

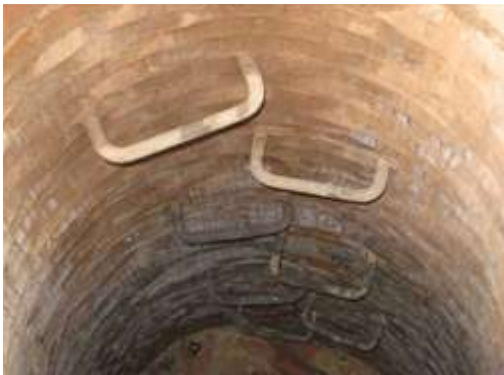
Steps

Count: **7** Missing: **0** ☐ Corroded

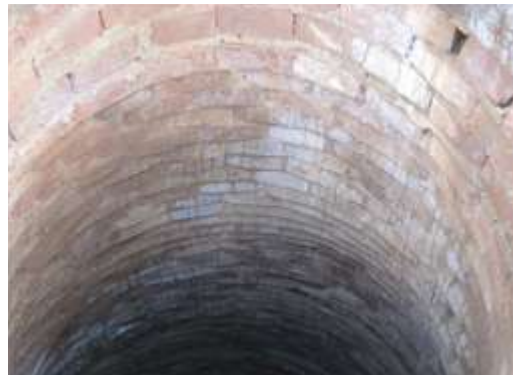
Defect 2

Infiltration: ☐ None ☒ **Joint** ☐ Cracks ☐ Mortar ☐ Roots ☐ Wall

Wall

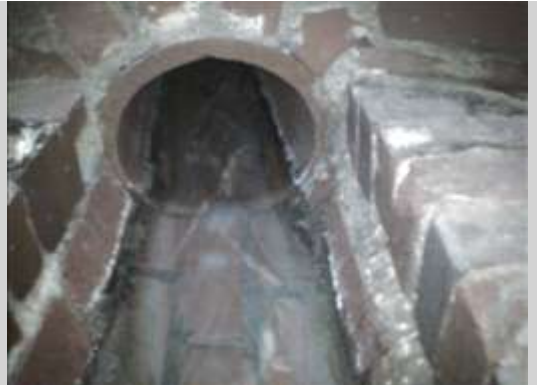
12 O'Clock Outflow

8 in. Circular Gravity Sewer
Pipe Out @ 12 O'Clock

Pipe Height: **8.4** (in.) Rod and Bar (Angled)
Pipe Material: **Clay** ☐ Pipe Lined
Invert Depth: **13.42** (ft.) Flow Characteristics: **Fast**
Deposits: ☒ None ☐ Mud ☐ Sludge ☐ Debris ☐ Grease
Silt Depth: (in.) Deposits Extent:
Infiltration: **None** Pipe Seal Cond: **Sound**

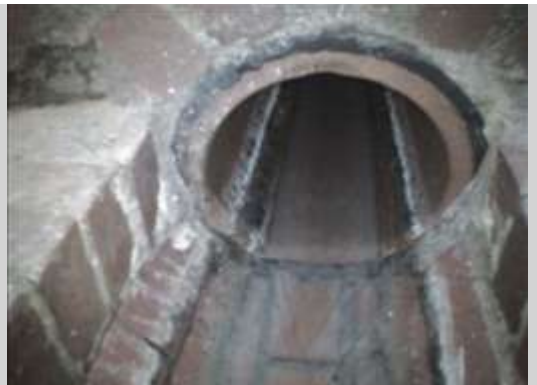
7 O'Clock Inflow

8 in. Circular Gravity Sewer
Pipe In @ 7 O'Clock

Pipe Height: **8.4** (in.) Rod and Bar (Angled)
Pipe Material: **Clay** ☐ Pipe Lined
Invert Depth: **13.45** (ft.) Flow Characteristics: **Fast**
Deposits: ☒ None ☐ Mud ☐ Sludge ☐ Debris ☐ Grease
Silt Depth: (in.) Deposits Extent:
Infiltration: **None** Pipe Seal Cond: **Sound**
